Te Tumu Natural Hazard Risk Assessment - Liquefaction

Prepared for
Tauranga City Council

Prepared by
Tonkin & Taylor Ltd

Date
June 2018

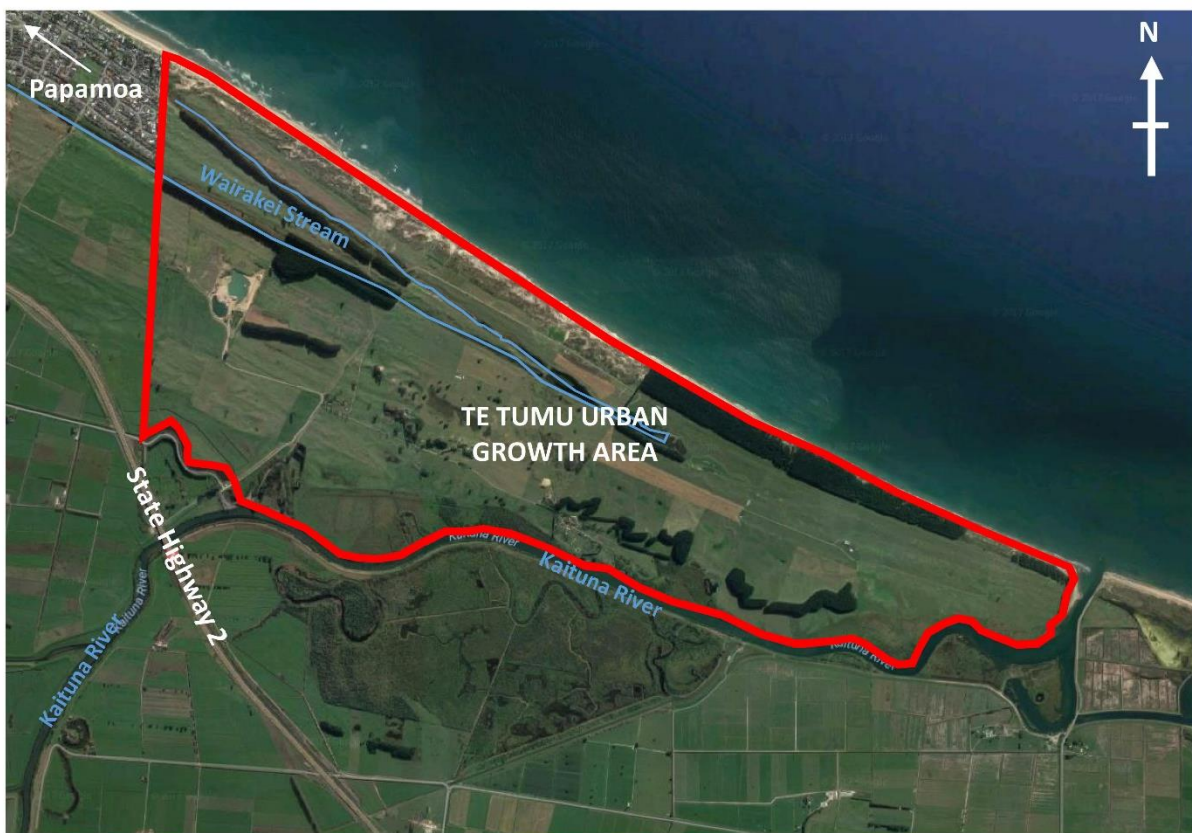
Figure 1-2: Aerial showing the Te Tumu Urban Growth Area - Source: Google Earth (refer to Figure A1 in Appendix A for a scaled Aerial Image)

The study area is outlined in Figure 1-2 and comprises a greenfield site situated between Papaoma East and Maketu. The Kaituna River is located along the southern and eastern boundary, and Papaoma Beach is located to the north.

The study area comprises approximately 764 ha of rural land. The topography of this area is variable. The stretch of land along Papamoa Beach consists of sand dunes that are at a relatively high elevation (ranging from approximately 3 to 11 m above sea level) whereas the land along the Kaituna River and the Wairakei Stream is at lower elevation (ranging from approximately 1 to 3 m above sea level). The central land throughout the site comprises mainly flat and slightly undulating land (elevation of approximately 4 to 7 m above sea level), with the land becoming increasingly hilly to the east. A ridge, which extends across most of the site, is located adjacent to the low lying areas along the Kaituna River, with the portion of land to the north of the ridge is also low lying. Wairakei Stream runs parallel to Papamoa Beach, which ponds within the eastern portion of the site.

The study area is owned by several landowners. A map outlining property boundaries is presented in Figure A2 in Appendix A. An operational sand mine is located within the eastern portion of the site and both a headrace and pump station as a part of a land drainage scheme are located adjacent to Bell Road.

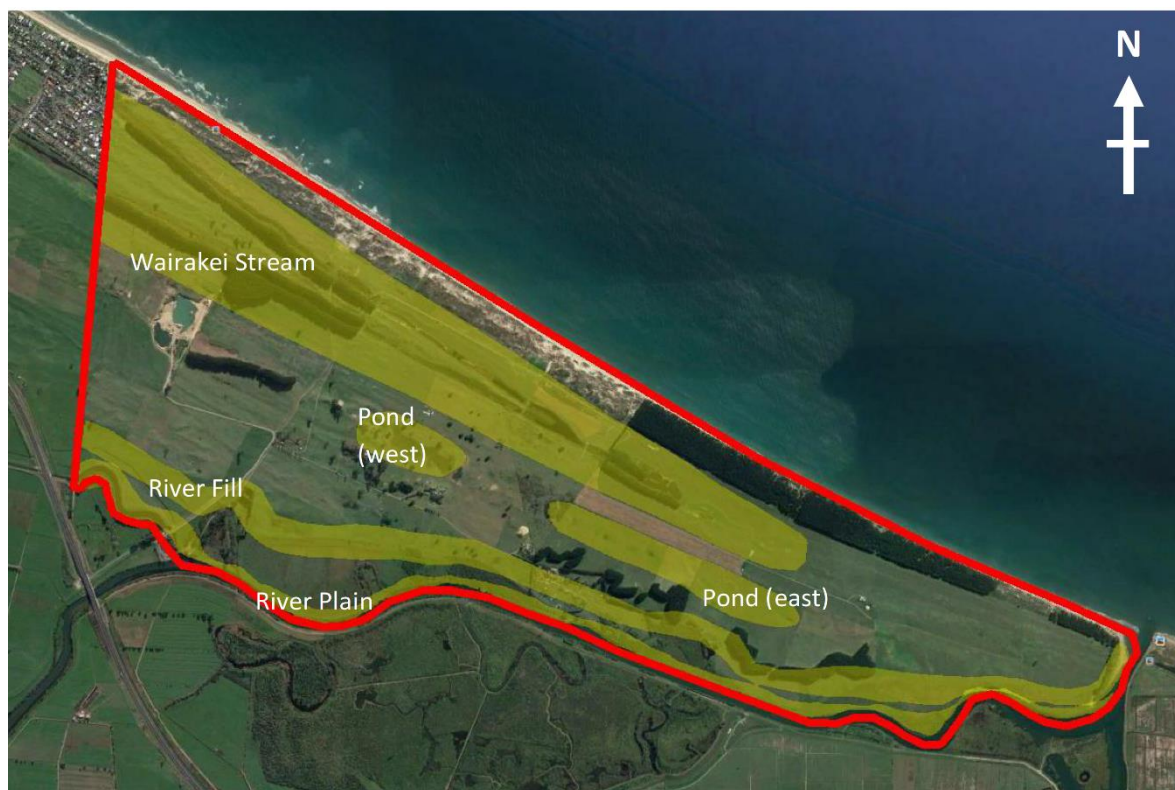
Figure 7-1: Map showing the potential lateral spread areas.

The potential for earthquake-induced lateral spreading to occur is typically greatest for land adjacent to free-faces such as riverbanks and terrace edges. The proposed finished ground surface for the Te Tumu Urban Growth Area includes five such areas. The areas susceptible to lateral spreading are identified in Figure 7-1 and Figure E1 in Appendix E and are referred to herein as:

- River Plain – the low lying river plain directly north of the Kaituna River
- River Fill – the edge of the fill north of the Kaituna River
- Stream – Wairakei stream which runs parallel to Papamoa Beach
- Pond (west) – the pond located in the western part of the site
- Pond (east) – the pond located in the eastern part of the site

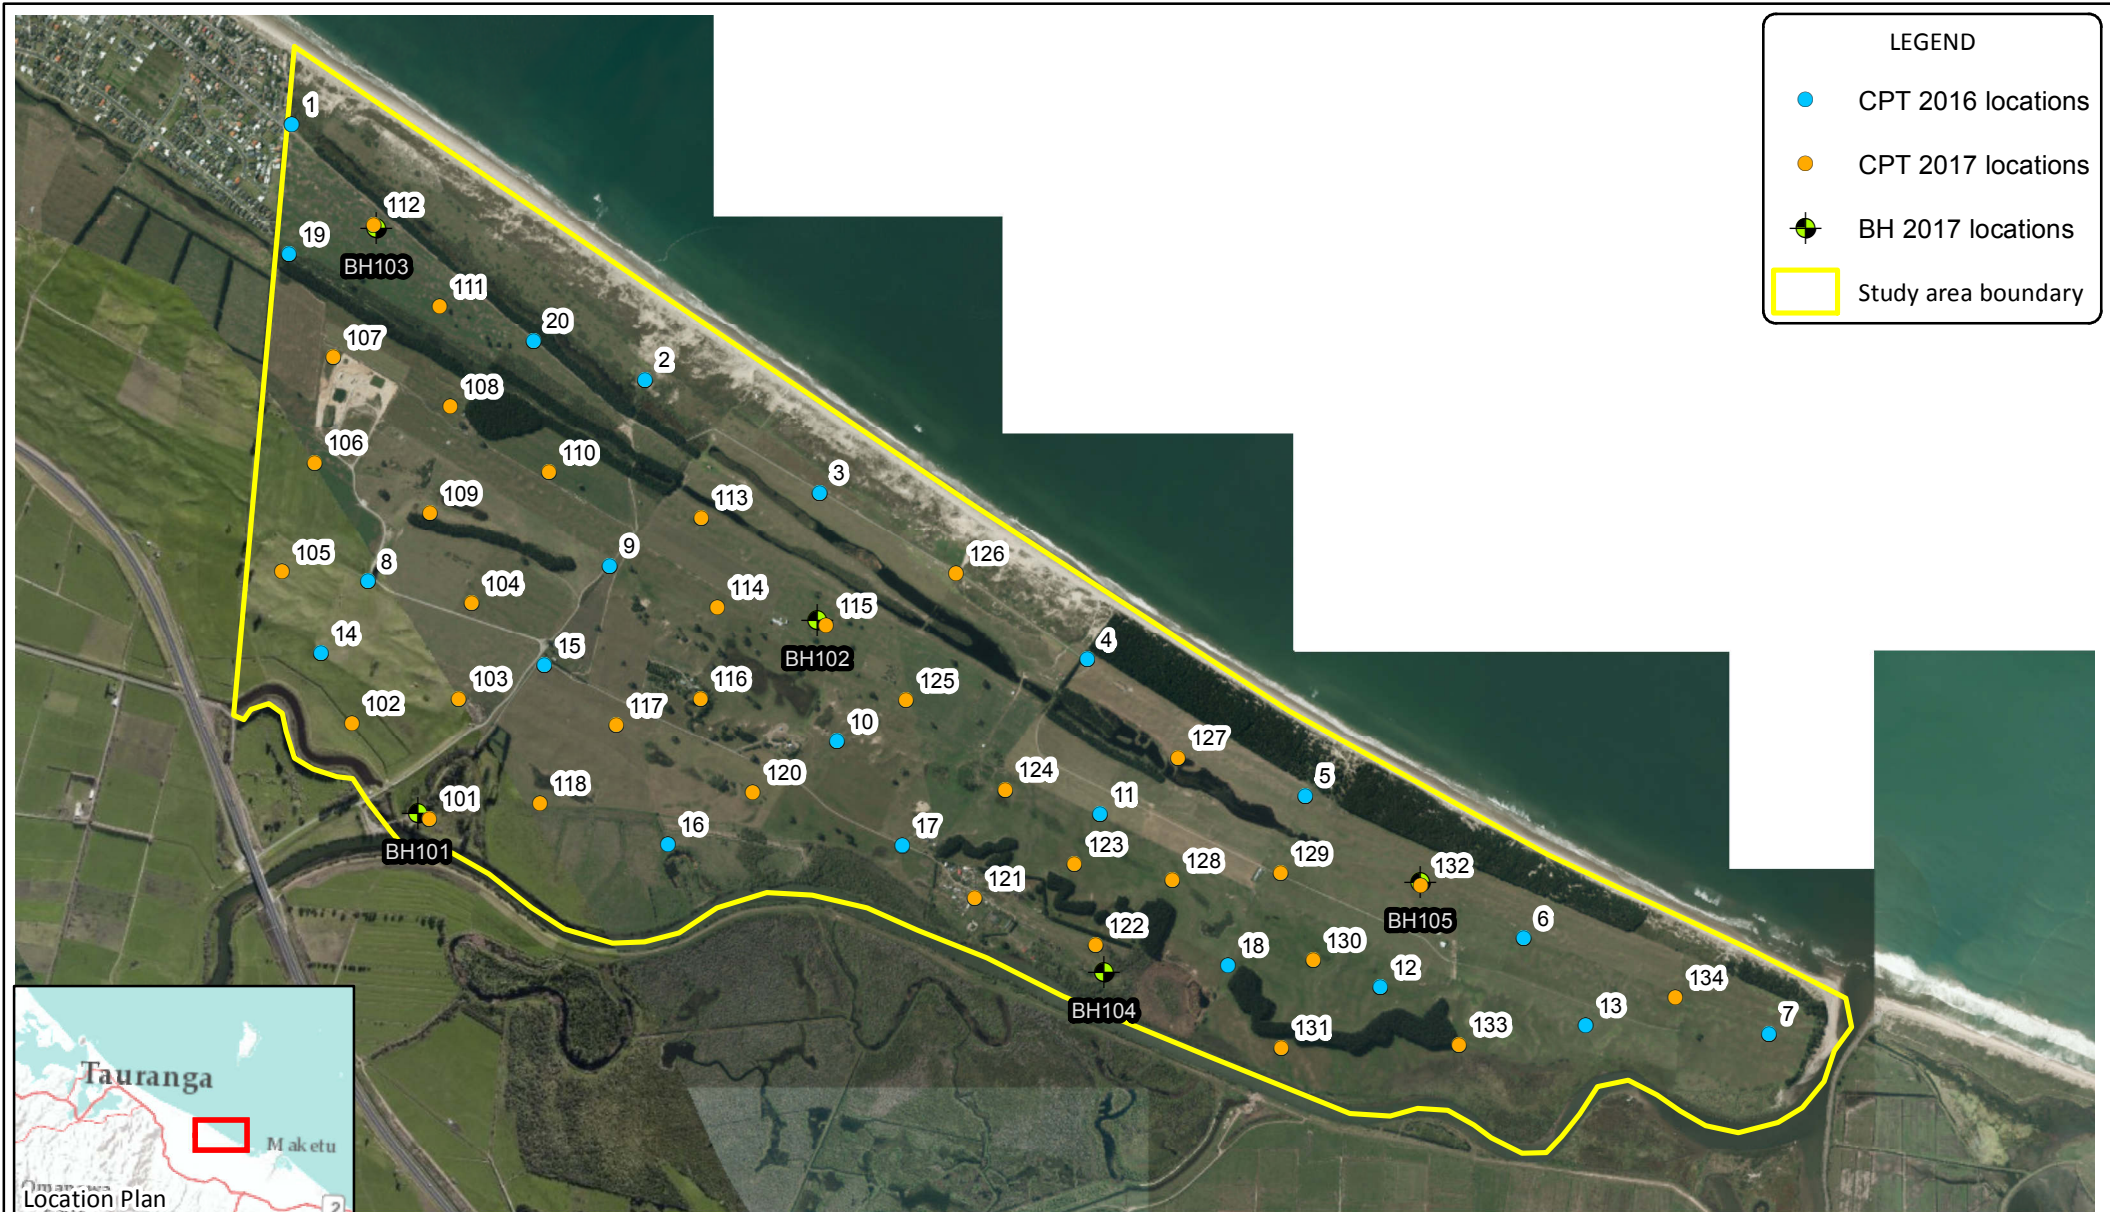
- **Figure A1 – CPT and BH locations overlaid on aerial imagery**
- **Figure A2 – CPT and BH locations overlaid on landowner blocks**
- **Figure A3 – CPT and BH locations overlaid on existing 2015 LiDAR DEM**
- **Figure A4 – CPT and BH locations overlaid on proposed DEM**

- CPT 2016 locations
- CPT 2017 locations
- BH 2017 locations
- Study area boundary

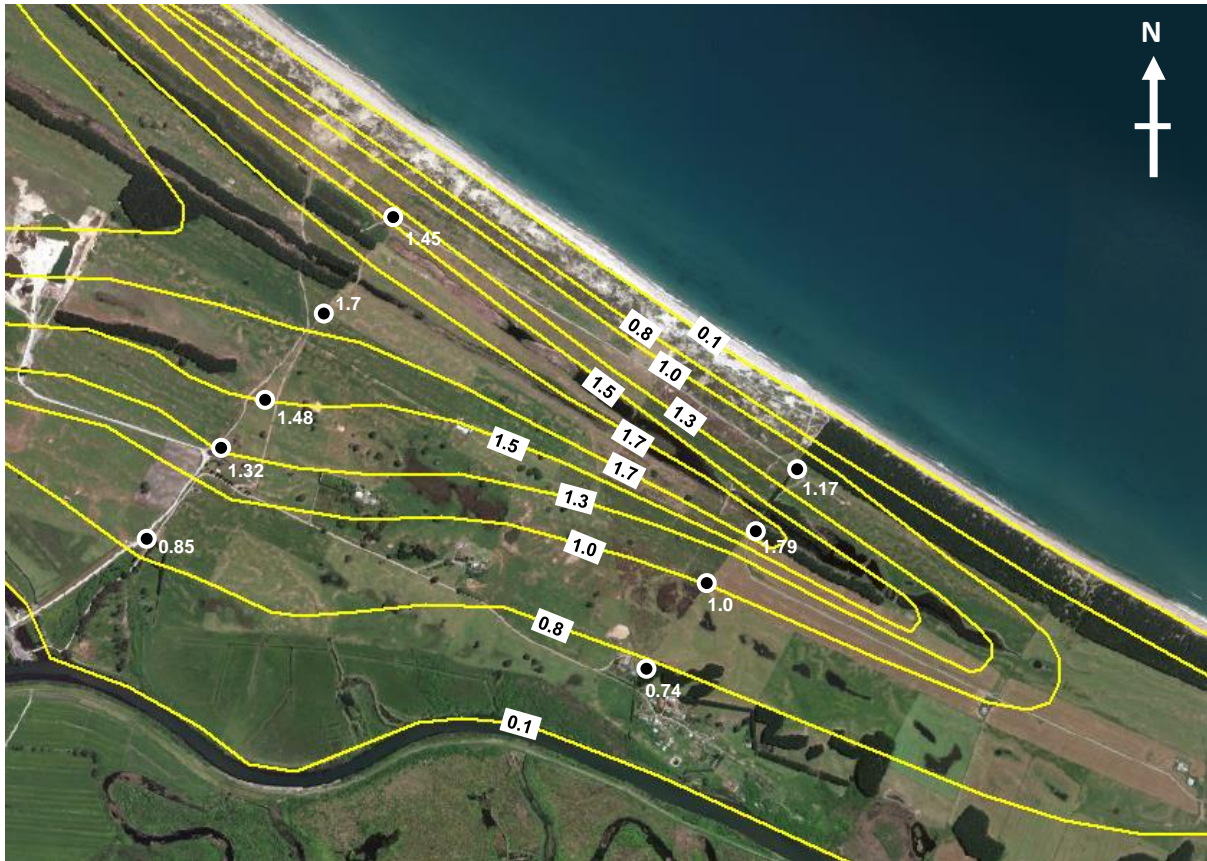
Figure C1 – Map showing the creation of median groundwater contours in the Te Tumu urban growth area.

An example of how the groundwater contours were developed from the monitored data is shown in Figure C1 below.
